USE OF PLANETSCOPE IMAGERY TO IDENTIFY GALODO IN SUNGAI JAMBU, PARIANGAN, TANAH DATAR, WEST SUMATRA

ABSTRACT: This study aims to identify and analyze the impact of the Galodo disaster in Sungai Jambu (Pariangan, Tanah Datar, West Sumatra) using PlanetScope satellite imagery. Galodo disasters, which are flash floods that transport materials such as soil and rocks, often occur in mountainous areas and cause significant damage to the environment and infrastructure. Located on the slopes of Mount Marapi, Sungai Jambu is one of the areas prone to galodo due to its geomorphology and high rainfall. The research methodology involved using PlanetScope images before and after the Galodo accident on May 13, 2024. Data processing included radiometric and geometric correction as well as image composite analysis to detect changes in land cover and river flow. The 3-2-1 and 4-3-2 composite images were used to detect changes in vegetation, stream conditions and degraded open land. The results showed significant changes in land cover and river flow due to the Galodo disaster, characterized by increased water turbidity and damaged vegetation.

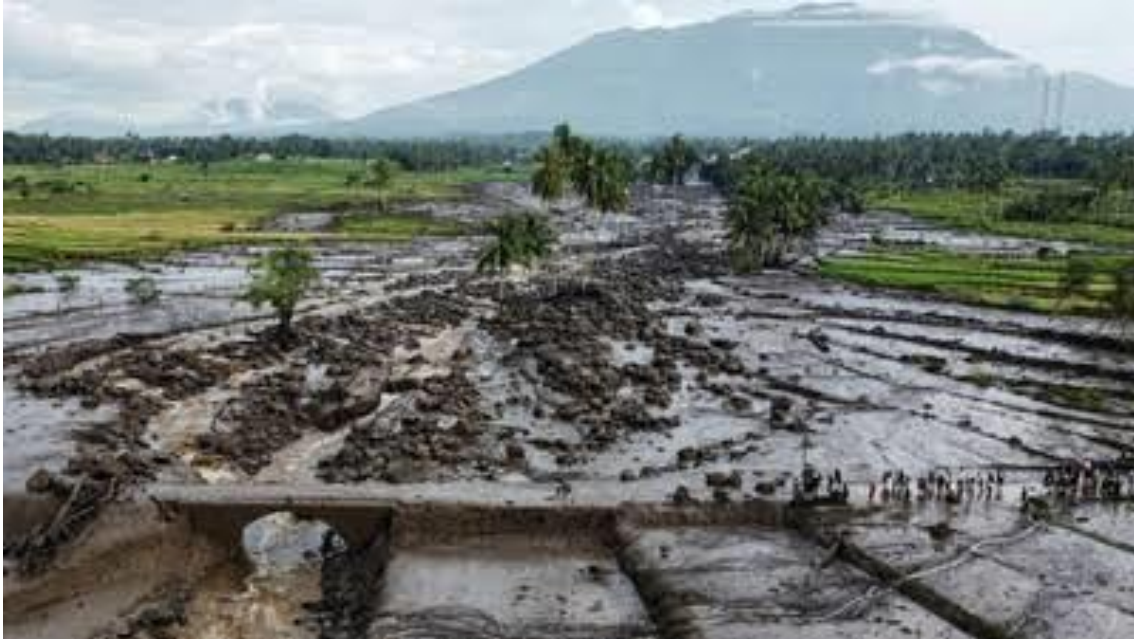
Figure 1: The appearance of Jambu River after the galodo of May 13, 2024

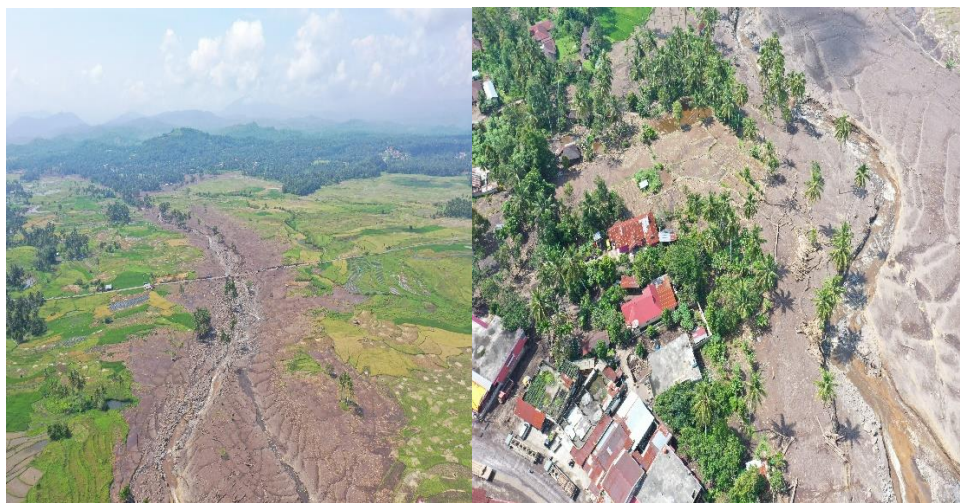
Figure 6. Jambu River after the Galodo disaster

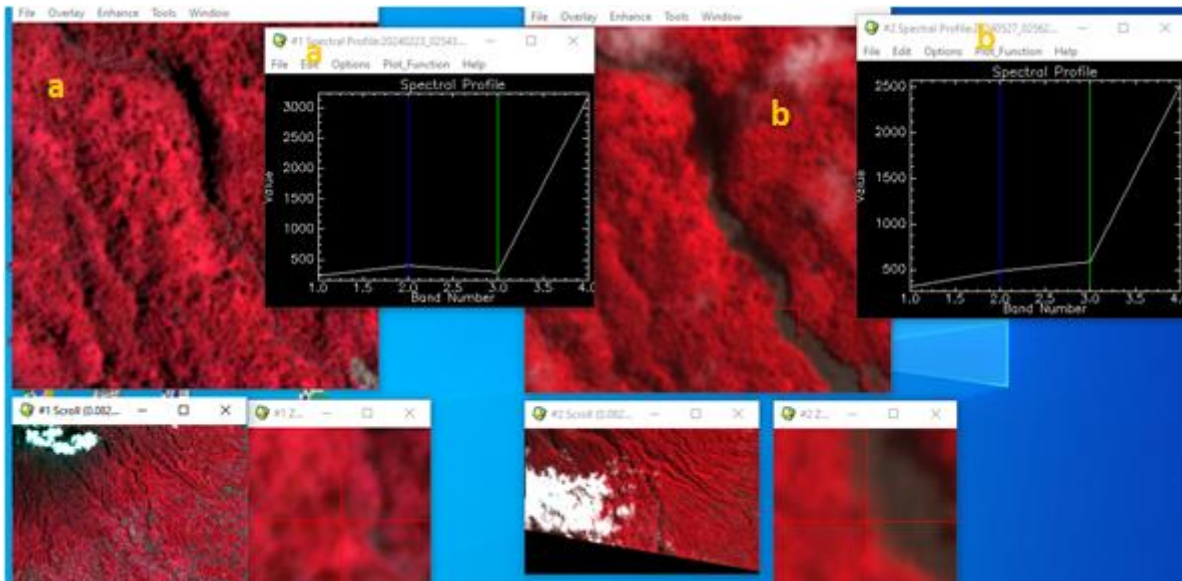
Figure 7. Composite Image 432 (False color) Image a (river flow before galado event and vegetation reflection curve), Image b (river flow after galado event and vegetated area reflection curve)

Healthy vegetation, which reflects a lot of light in the NIR band, usually appears bright red in this composite. Before the galado, areas of healthy vegetation dominated the image, indicating good land cover. However, after the galado, many areas that were previously covered with healthy

vegetation experienced significant discoloration. Severely affected areas show darker colors or turn brown or gray, indicating vegetation damage or complete removal of vegetation cover due to avalanches and other material carried by the flow.
