# ANALYSIS OF THE NON-COMPATIBILITY OF GEOMORPHOLOGICAL CONDITIONS TOWARDS FLASH FLOOD VULNERABILITY IN ANAI VALLEY

**ABSTRACT:** Flash floods are a hydrometeorological disaster that frequently occurs in mountainous watersheds, particularly in areas with land use that is not in accordance with its natural geomorphological conditions. This study aims to analyze the geomorphological characteristics of the Anai Valley, determine the level of flash flood vulnerability based on the integration of biophysical parameters, and assess the contribution of geomorphological mismatches to increasing flash flood vulnerability. This study uses a Geographic Information System (GIS) approach with a weighted overlay method through the integration of slope gradient, soil type, land use, river buffer, and rainfall parameters. The results show that the Anai Valley area is dominated by steep to very steep slopes, volcanic and alluvial soil types, and land use activities that develop along the Batang Anai River. High to very high flash flood vulnerability zones are concentrated in the valley plains and river corridors. Land use mismatches on steep slopes and river boundaries contribute significantly to

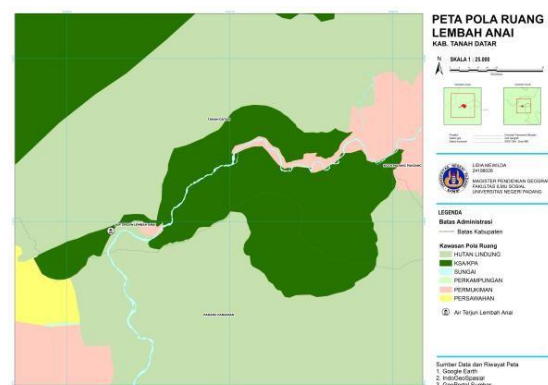
Fig.4 Anai Valley spatial pattern map

Based on the 1:25,000 scale Anai Valley Spatial Pattern Map of Tanah Datar Regency, it can be seen that the study area is dominated by protected areas and nature reserves/nature conservation areas (KSA/KPA) that stretch following the morphology

of the valley and hill slopes along the Anai Watershed. This area functions as a water catchment area and controls hydrological balance, especially in the upstream and middle of the valley [1].

Along the main river corridor of the Anai Watershed, residential and village zones have developed following the river's course and regional accessibility, particularly in the relatively gentle valley areas. The presence of settlements adjacent to the river indicates pressure on land use in the riparian zone, which geomorphologically increases vulnerability to flash floods.

Land use, including rice paddies, has been identified in the downstream and transitional areas leading to Padang Pariaman Regency, which generally occur on alluvial plains with low slopes. This pattern reflects land use that adapts to the flat topography and availability of surface water, but remains at risk of river overflows during periods of heavy rainfall.

This mismatch in spatial patterns has direct implications for increasing the vulnerability of the Anai watershed area to flash floods and environmental degradation [14]. Therefore, the spatial pattern map displayed is important as a basis for evaluating the suitability of land use [15]. As well as considerations in spatial control, especially in protected areas, river boundaries and disaster-prone zones in Tanah Datar Regency [8].
